DEVELOPMENT OF WELDING TECHNIQUES AND FILLER  
METALS FOR HIGH STRENGTH ALUMINUM ALLOYS

Progress Report Number 33  
Ninth Quarterly Report  
Project No. 1063-7

SOUTHWEST RESEARCH INSTITUTE  
SAN ANTONIO HOUSTON

Reporting Period  
1 January 1964 to 31 March 1964

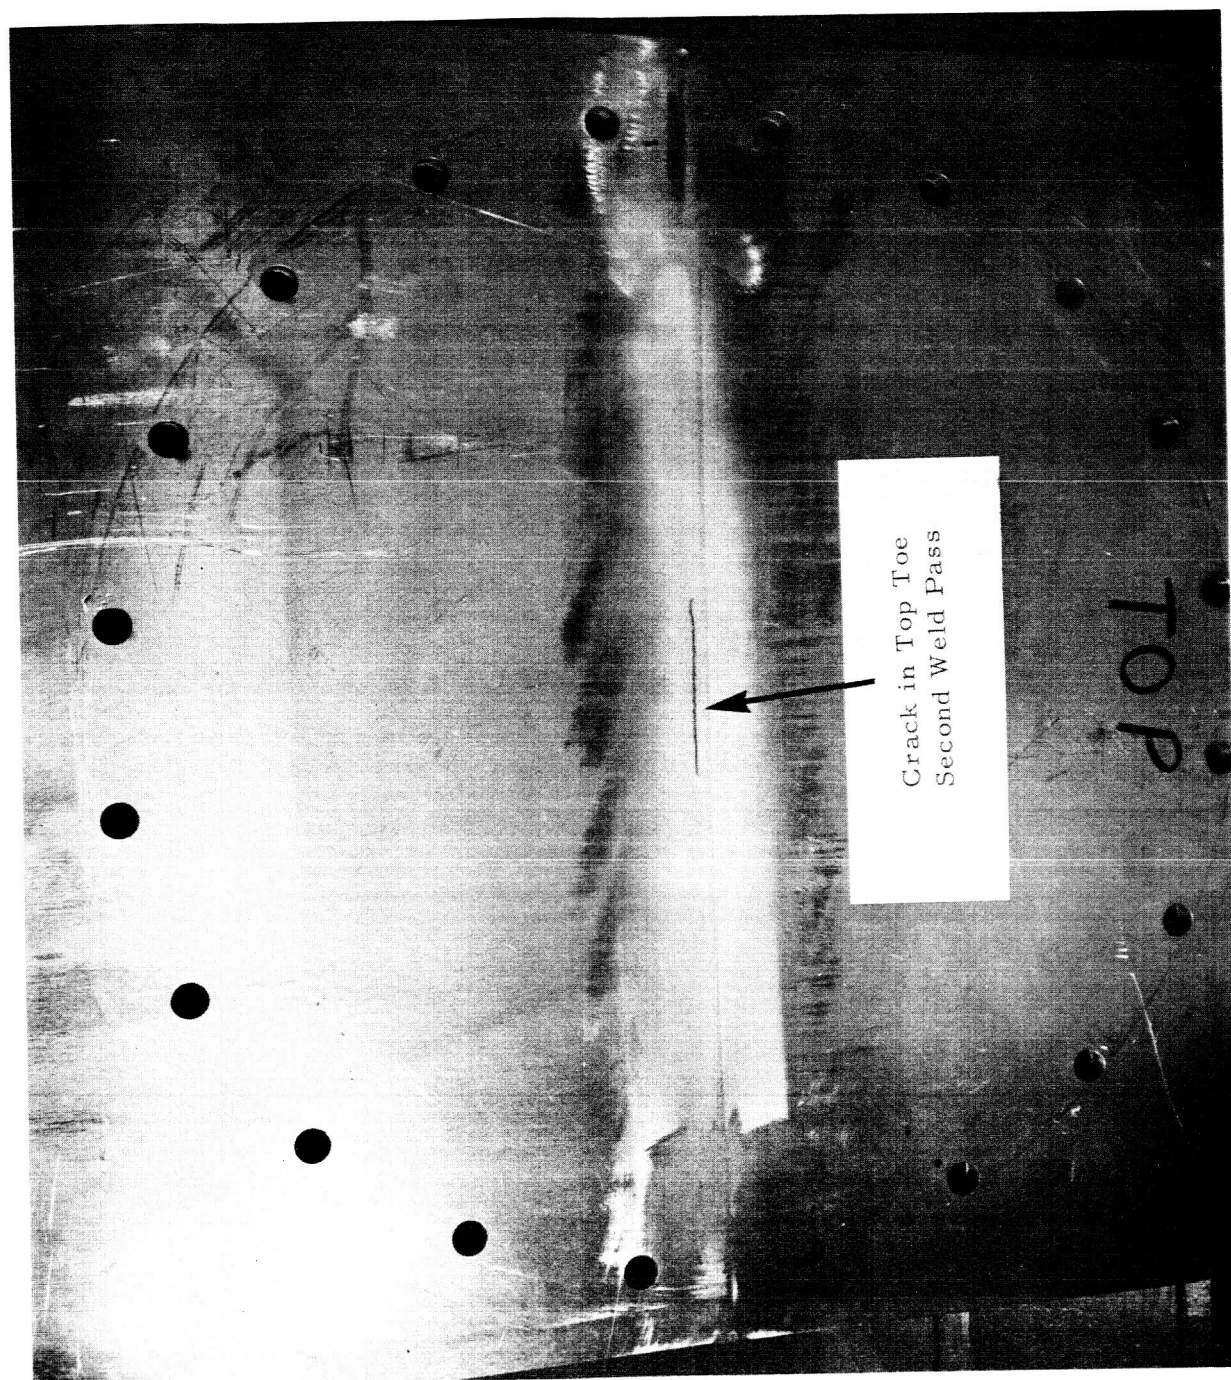
FIGURE 13. CRACK ON INNER SURFACE OF PANEL NO. 41

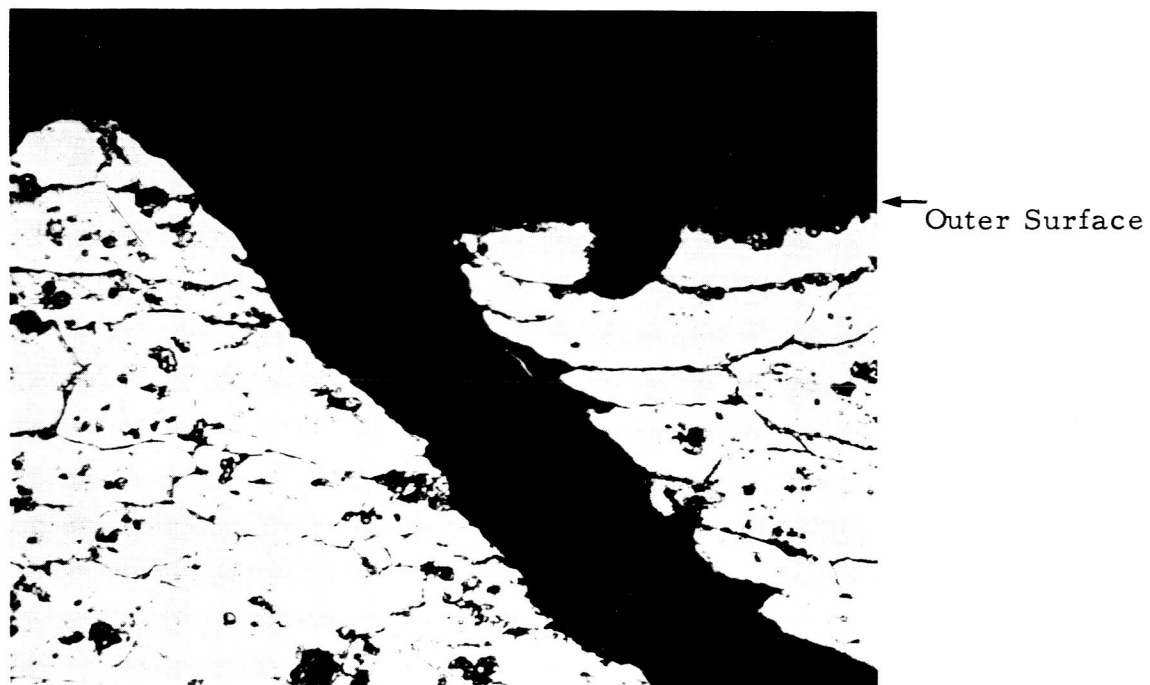
FIGURE 18. CROSS SECTION OF RUPTURE AT TOP OF  
OUTER SURFACE OF PANEL 41

Figure 18 shows a cross section of the rupture at the outer surface. Figure 19 illustrates the path of the rupture as seen looking down on top of the outer surface of the bulged panel. The rupture is seen to follow a path in the weld metal very close to the HAZ weld metal fusion line (toe of weld).

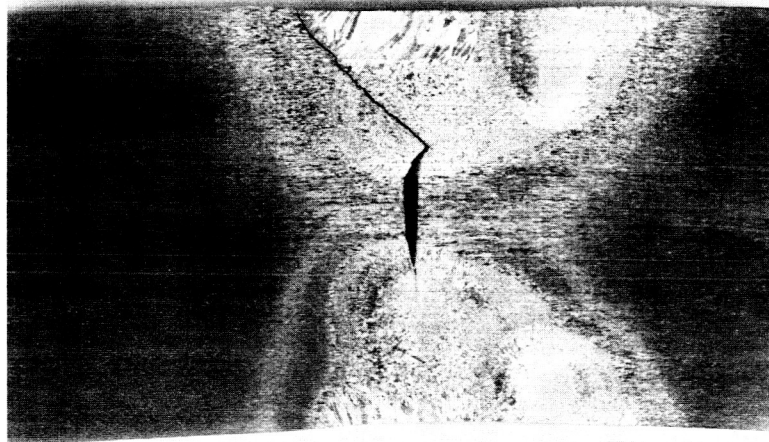
FIGURE 22. CROSS SECTIONS THROUGH CENTER AND ENDS OF RUPTURE  
IN SQUARE BUTT AND FILLER WELDED (CROWNS GROUND OFF)  
HYDRAULICALLY BULGED PANEL NO. 46
